PSPC-COT Test Results in JAPAN

Industry Joint Working Group/COTCPS
7 October 2009

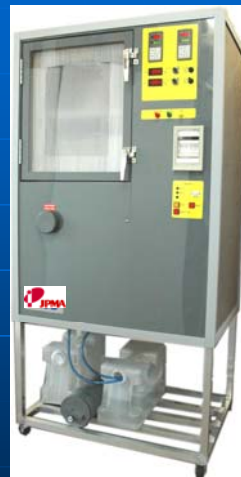
Test equipment (Vapor test)

Test cabinet

Chamber Capacity : Approximately 135 Liter

Indicator :

Digital Temperature and humidity indication,

Digital Indication Gas Flow, Concentration, Recorder

Temp Set-Up :

25 ~ 60 Digital Set-Up (Cycle Test can be added)

Humidity :

60 ~ 98% RH Digital Set-Up (Cycle Test can be added)

Gas Flow :

0 ~ 200CCM/min (Electronic mass flow controller with Shut off function)

Gas Concentration :

10ppb ~ 500ppm (the type, concentration, indication and Automatic concentration set-up functions are optional.)

Total Flow : 360 liter/h

Weight : 85Kg (without bomb tank)

Cooler : Contained a cooler for dehumidification (200W)

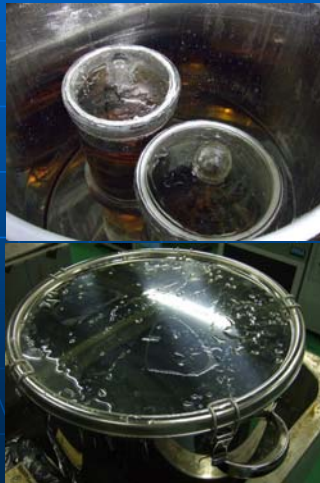
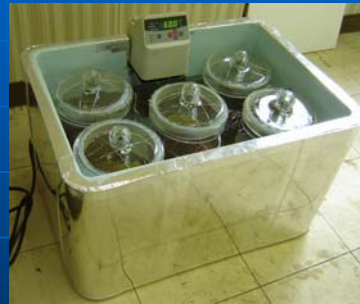
Test equipment (Immersion test)

40°C

60°C
